Mission Creek Channel and Streamway Width Assessment

March 2010

Mission Creek Streamway Width Study

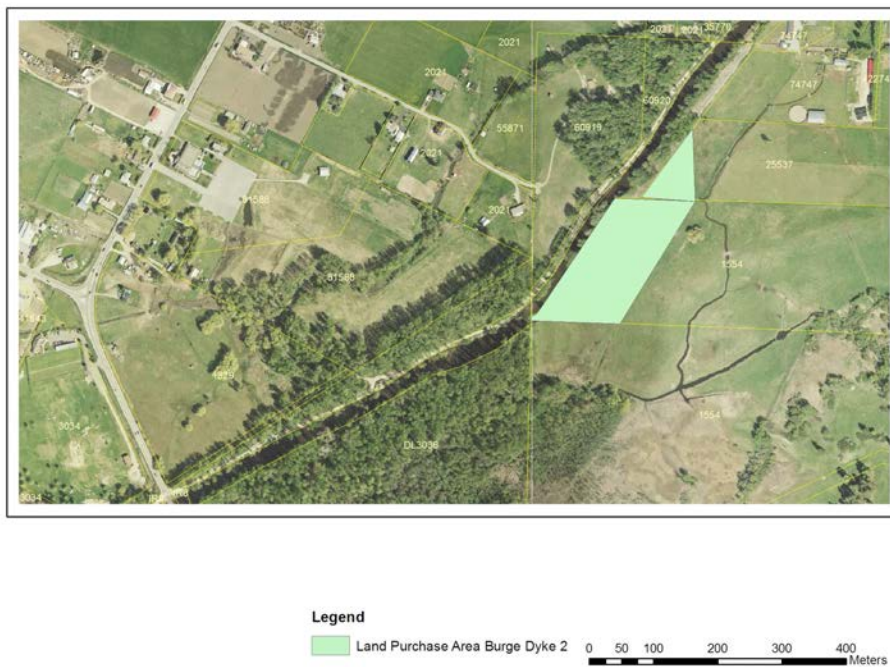
Figure 6-8. Areas to purchase for section 2: Burge Dyke 2 option.

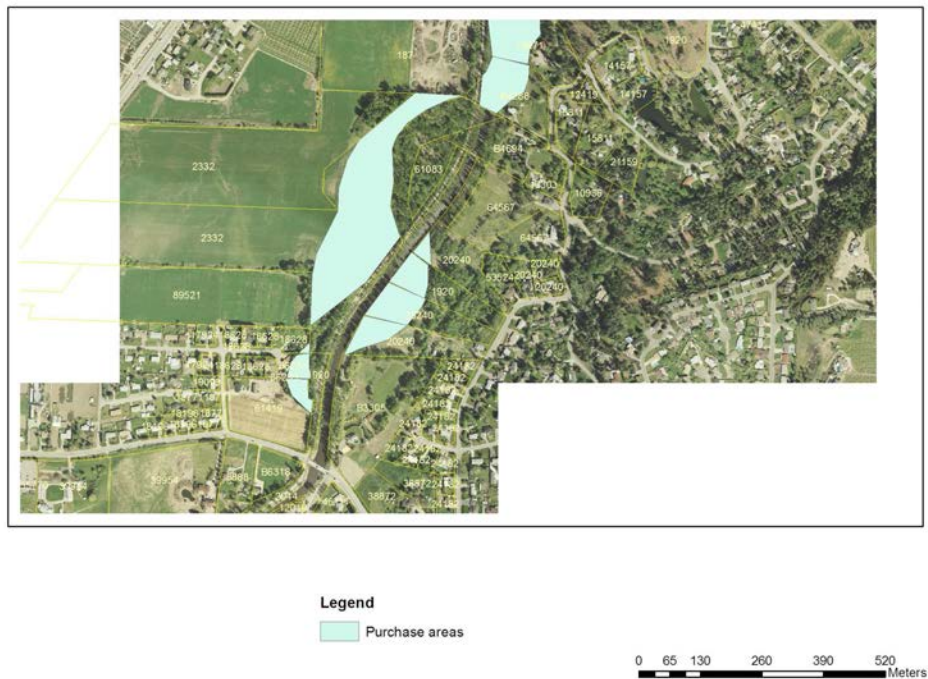
Figure 6-14. Areas to purchase for section 4: Burge Dyke 1 option.

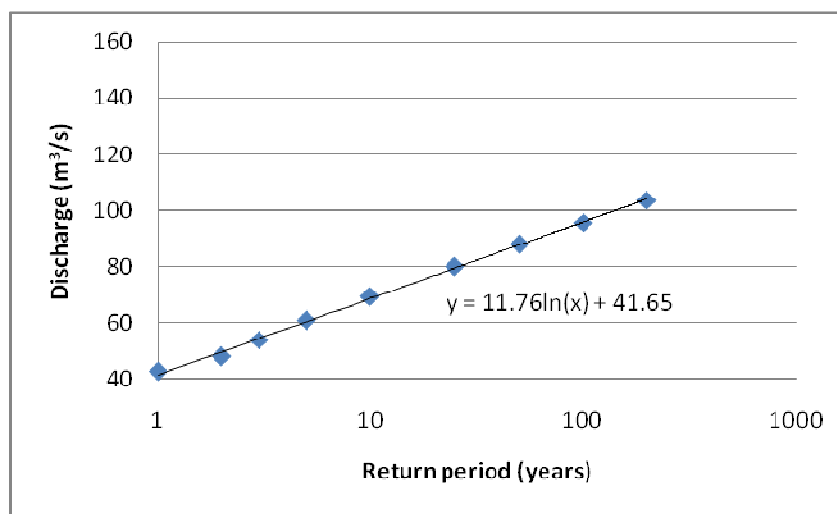
Figure 7-1. Flood frequency analysis for Mission Creek from 1949-2006 (from Burge 2009)

Boundary conditions for the model mean annual flood ($52.1 \text{ m}^3/\text{s}$), 100 yr flood ($95.8 \text{ m}^3/\text{s}$) and the 200 yr flood ($104 \text{ m}^3/\text{s}$) are shown in Figure 7-1. These are similar values to those used in Gaboury et al. (2004) of 40, 107 and 115 for the 2 year, 100 year and 200 year floods respectively.

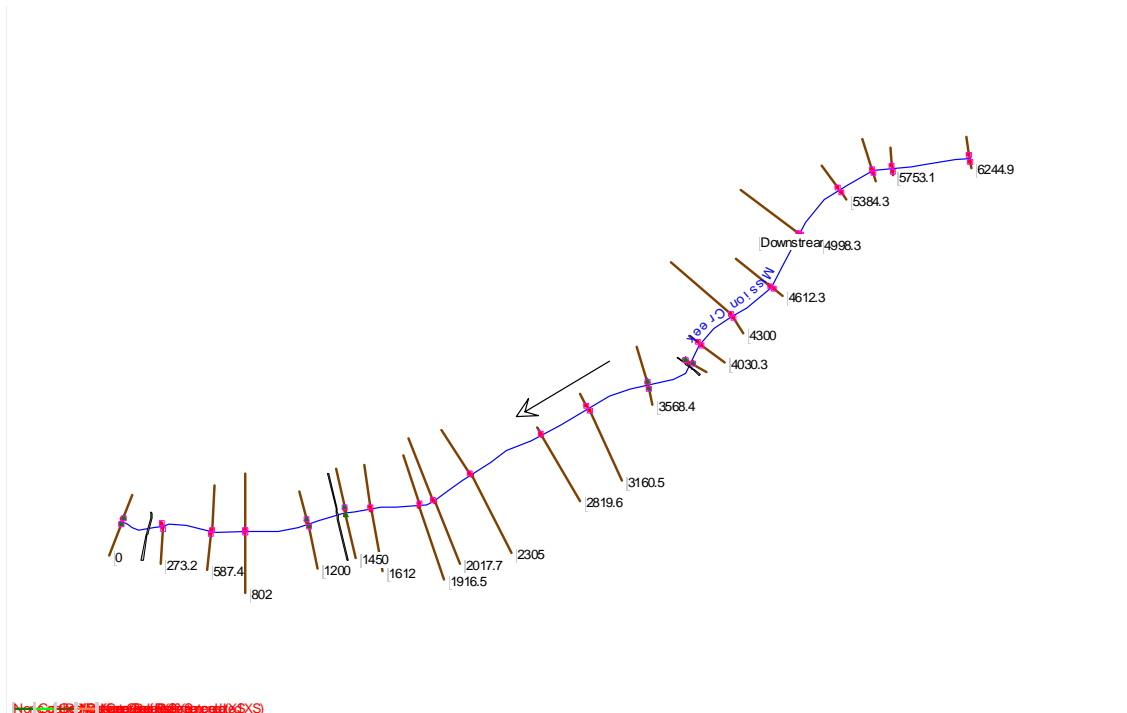
Figure 7-3. HEC-RAS Cross Sections and Bridges.

The cross-sections are an important input variable for HEC-RAS modeling. Therefore several steps were completed to produce the final cross-sections. First, the maximum floodplain width was mapped. This represents the maximum possible floodplain extent. The maximum floodplain width was used as the beginning and end of the floodplain cross sections input into HEC-RAS. Alternative dyke locations were superimposed on these cross sections. Colour orthophotos and a 1m resolution contour map were used to determine the location of the modern floodplain. This represents the absolute maximum possible floodplain width given the constraints of modern land use including housing. The maximum possible floodplain width was determined by angling the floodplain away from constrictions such as bridges. Benvoulin Road was used as the furthest possible point from Mission Creek that the floodplain could extend on the right bank. The Mission Creek Golf and Country club was excluded from the floodplain as were any subdivisions. The high banks (>3m tall) delineated the extent of the floodplain on the left bank where they occurred. The extent of the cross-sections can be seen in Figure 7-3.

Three bridges occur within the study reach: KLO Bridge, Casorso Bridge, and Gordon Bridge. The bridge cross-section underneath each bridge was measured in the field and input into HEC-RAS, including the location of piers.

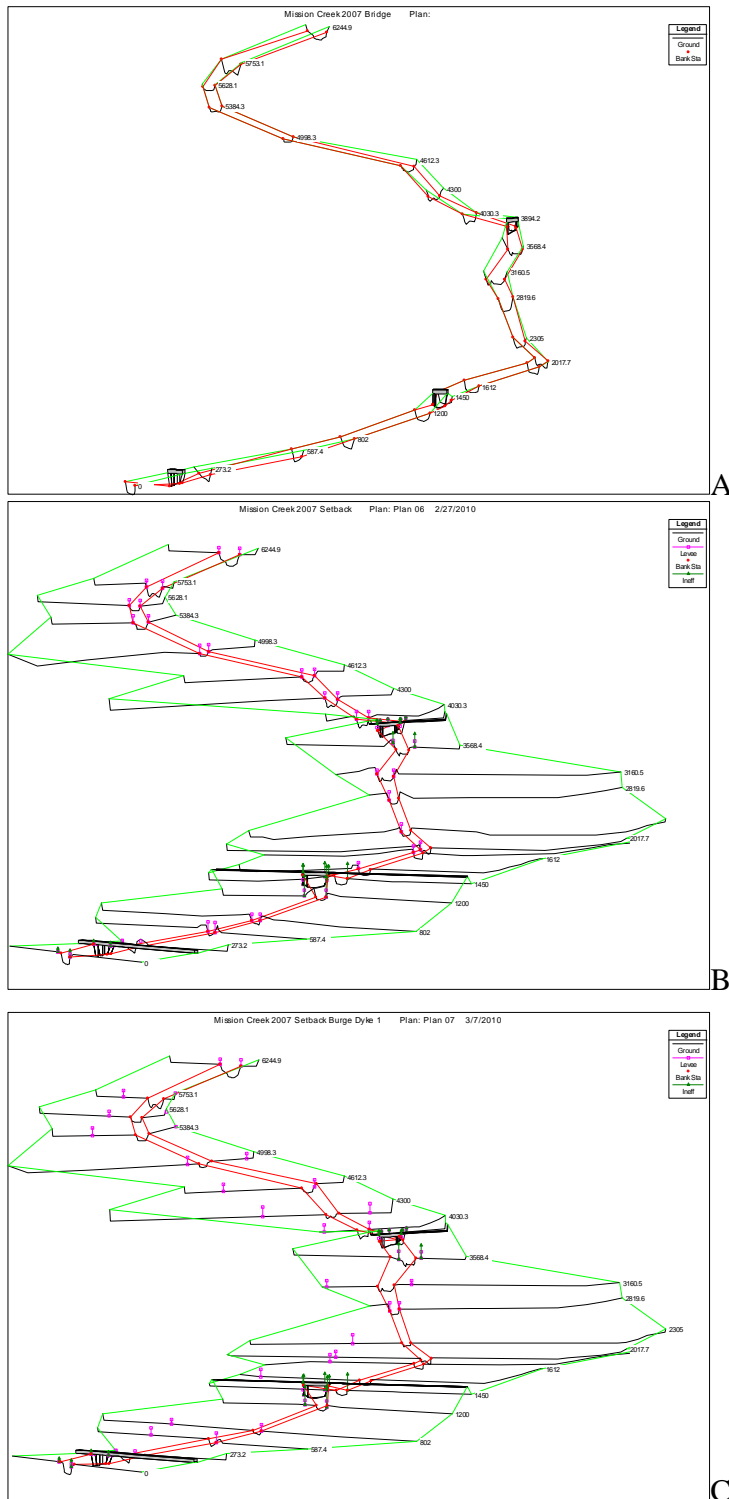
Figure 7-4. Cross sections for HEC-RAS (A) field measured cross-sections, (B) Burge Dyke 1 locations super imposed on field measured cross-sections merged with floodplain elevations obtained from 1m contour map, (C) Burge Dyke 2 locations superimposed on same cross sections as B.

The shape of the field measured cross-sections, the combined field channel cross-sections and the floodplain cross-sections obtained from the contour map and the final model input cross-sections can be seen in Figure 7-4.

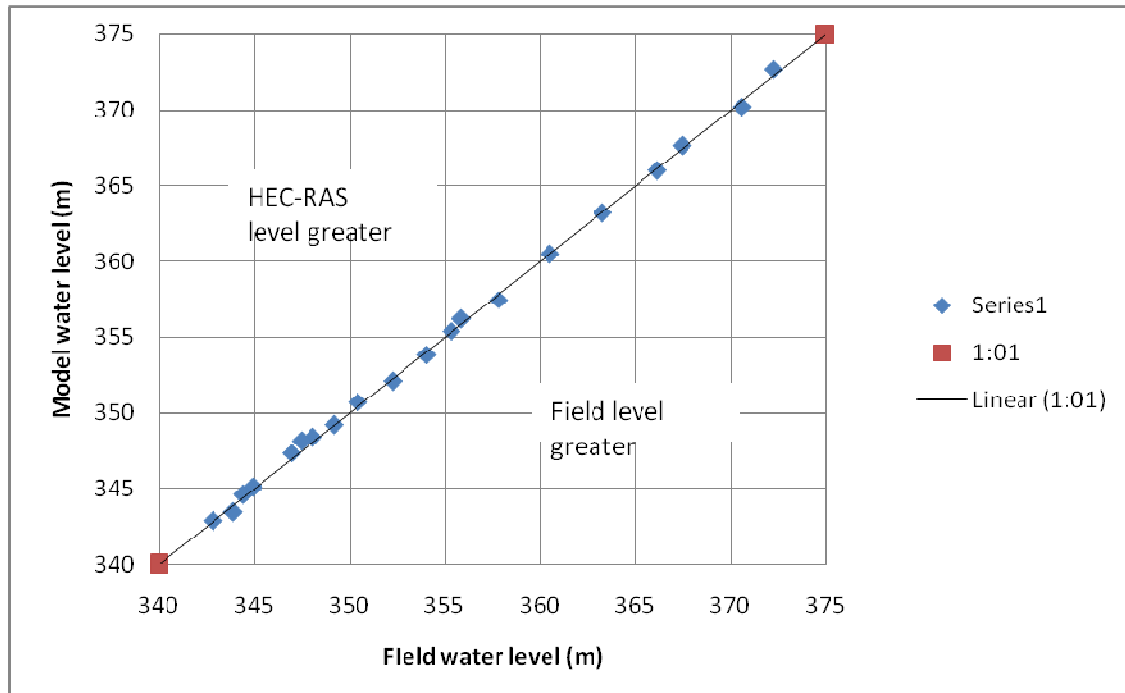
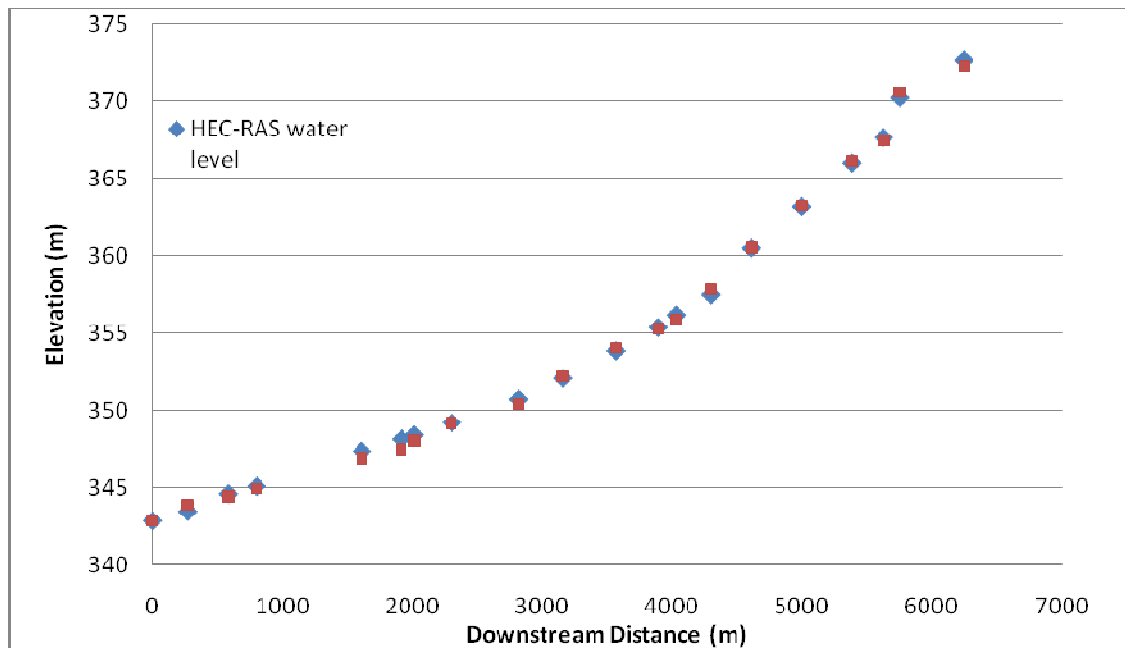
Figure 7-6. Comparison of modelled and field measured water level elevations. A) displays the modelled elevations plotted against the field measured water levels, while B) shows the elevations plotted downstream.

The model did quite well in estimating the water surface elevation (Figure 7-6). The average difference between the HEC-RAS modelled water surface elevation and the field measured water surface elevation was 36.3 cm. This value is within the same range as the error in determining the water surface elevation in the field. As seen in Figure 7-6, the model did the worst at around 2000 m downstream and at the upstream end.

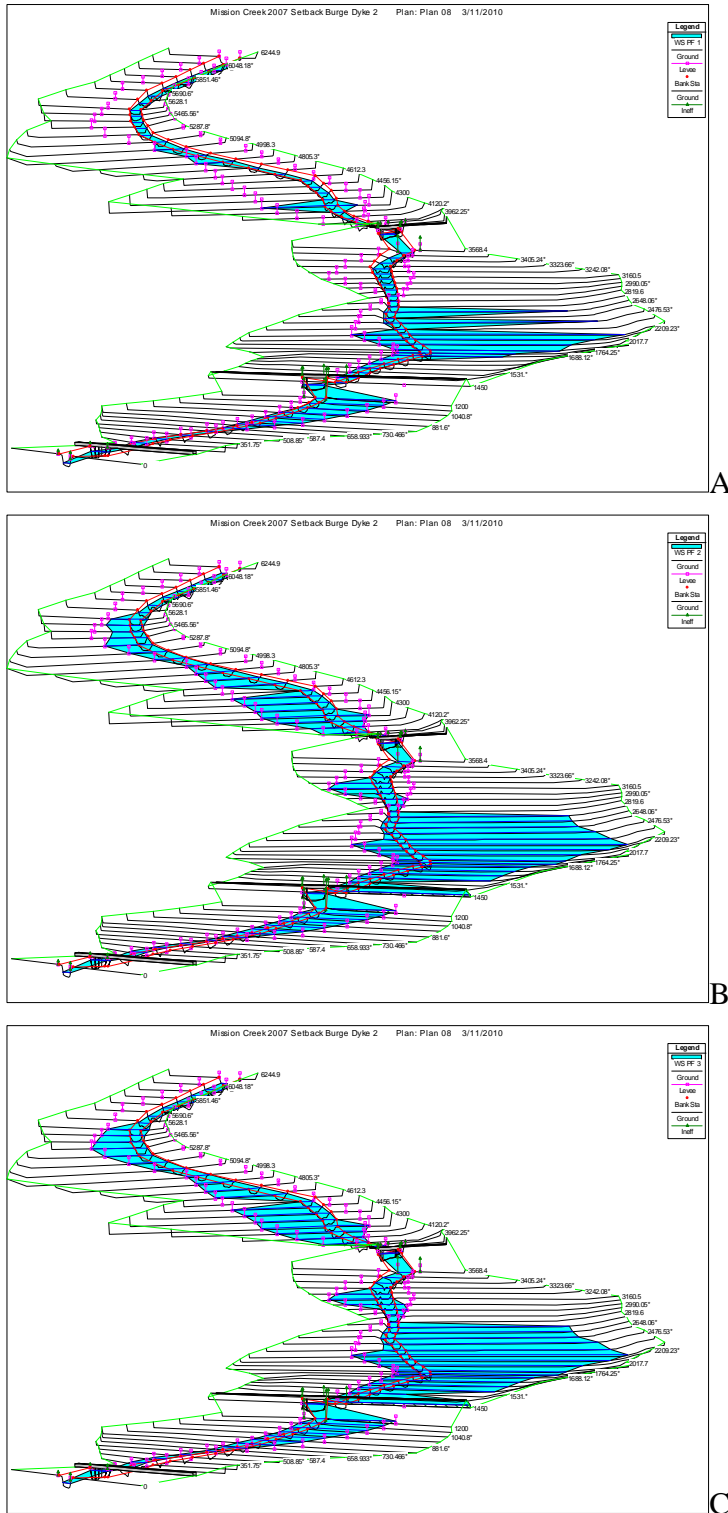
Figure 7-11. Water surface locations for the Burge dyke 2 locations for the (A) mean annual flood, (B) 100 year flood and (C) 200 year flood.

Finally, the model was run with the Burge dyke 2 locations superimposed upon the floodplain. The flow was constrained by dykes that are more narrow than the Burge Dyke 1 option but setback compared to the current condition (Figure 7-11). The Burge dyke 2 locations differ from the Burge dyke 1 locations only in sections 1, 2 and 3. Only these sections will be discussed. Inundation of the floodplain again occurs under the relatively low discharges at the mean annual flow. Again, the effect of the bridges can be seen on the water surface elevation plot, with each bridge creating a back water upstream of the restriction (Figure 7-12). The model becomes unstable between Casorso and KLO bridges as indicated by the oscillation of the water surface profile at higher flows. These results should again be interpreted with this in mind.
